Article In-Process Monitoring of Laser Surface Modification

Citation: Marimuthu, S.; Pathak, S.; Radhakrishnan, J.; Kamara, A.M. In-Process Monitoring of Laser Surface Modification. *Coatings* 2021, *11*, 886. https://doi.org/10.3390/ coatings11080886

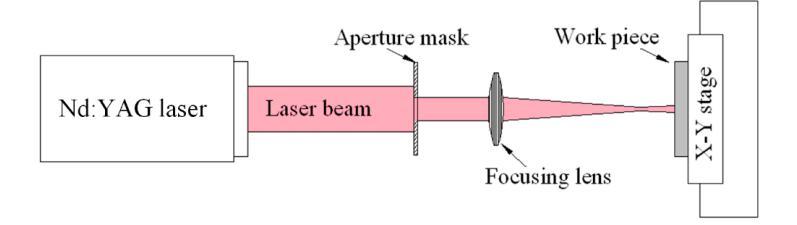
Shown in Figure 1 is a schematic layout of the apparatus used in the conduct of the laser cleaning experiment. The substrate material used as samples for the in-process monitoring investigation was titanium alloy (Ti6Al4V) with dimensions of $50 \times 50 \times 1 \text{ mm}^3$. Some of the samples were contaminated with industrial machining coolant to study the effect of the contaminant on laser cleaning performance. The application procedure of the contaminant and its thickness were carefully controlled in all the samples in accordance with laid-down industrial procedures. The laser source used for the experiment was a frequency-tripled Litron Nd:YAG lamp-pumped laser with a wavelength of 355 nm, pulse duration of 8 ns, and maximum pulse frequency of 10 Hz. The laser beam was incident on an opening of 10 mm², situated on a 1-mm thick object mask of a stainless-steel sheet, and then passed through a focusing lens of 200 mm focal length. The mask enabled the selection of a laser beam of uniform intensity from the frequency-tripled Nd:YAG laser. Careful control of the mask-to-lens and lens-to-target distance ensured the required laser spot size over the target surface. Four fluence levels of 0.4 J/cm², 0.55 J/cm², 0.7 J/cm², and 0.85 J/cm^2 were respectively considered in this study in order to understand the influence of laser fluence on the cleaning and monitoring characteristics.

Figure 1. Schematic of the experimental layout of the Nd:YAG laser cleaning system.

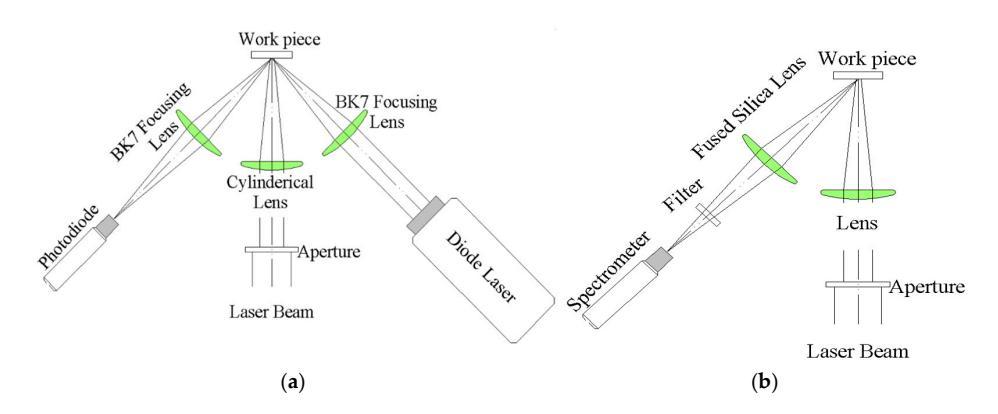
With respect to the integration of an in-process monitoring system to the laser cleaning system, schematic layouts of the experimental arrangement for the PBR and PES as integrated into the laser cleaning system are shown in Figure 2a,b, respectively.

In Figure 2a the experiment for the PBR is shown to have involved the use of a diode laser (Thorlabs CPS635R) with a 635 nm wavelength and 2.9 mm unfocused beam diameter as a light source. The diode laser beam was focused with a spherical lens at approximately 45° to the surface of the workpiece within the imaged frequency-tripled Nd:YAG laser spot. The beam diameter of the diode laser over the surface was controlled at 0.25 mm. Since the laser beam was wide enough (minimum 1 mm²), the diode laser beam was imaged at the laser spot's centre. The light reflected from the surface of the workpiece was focused using another lens into a Thorlabs PDA10A2 photodiode to increase the light intensity on the sensor surface. The output response of the photodiode was then measured using a digital oscilloscope (Picoscope 5244D) as a means of monitoring the laser cleaning process.

The experimental arrangement in Figure 2b for the PES system is shown to have an Ocean Optics Maya2000 spectrometer as a replacement of the probe beam and photodiode

in the PBR system. The elemental spectra were obtained using a fused silica lens of 100 mm focal length, which imaged the scattered emission at 45° onto an optical fiber that was coupled to the spectrometer. An optical filter of < 400 nm cut-off was placed in front of the fibre to eliminate the frequency-tripled Nd:YAG radiation from the sensor.

Figure 2. Schematic illustration of the online monitoring arrangements, (**a**) For the probe beam reflection (PBR), (**b**) For the laser plume emission spectroscopy.

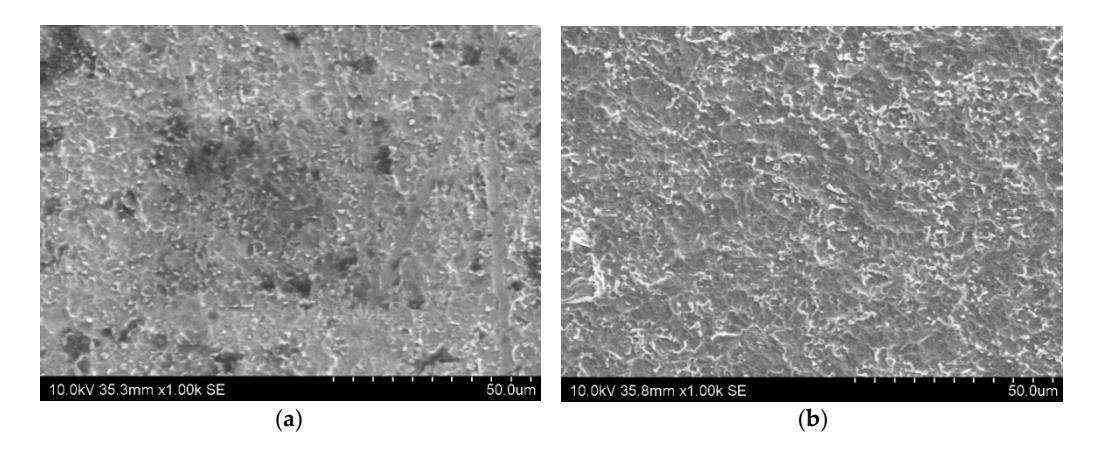
The scanning electron microscopic images of the titanium sample before and after laser cleaning are shown in Figure 3, where no change in substrate surface morphology was observed after the laser cleaning process. This implies the frequency-tripled Nd:YAG laser can successfully remove hydrocarbon-based surface contaminants, without inducing any changes or damage to the substrate. The laser cleaning mechanism observed in Figure 3 is based on selective vaporization that is attributed to the low ablation threshold of the contaminants for a wavelength of 355 nm [7]. An observation worth mentioning at this point is that the contaminants over the substrate cannot be fully removed for laser fluence less than 0.4 J/cm², while at the same time the substrate starts to get damaged by melting and ablation for laser fluence beyond 0.85 J/cm².

Figure 3. Scanning electron microscopic images showing the sample surface condition (Ra of ~450 nm) (laser cleaning performed with a frequency-tripled Nd:YAG laser operating at a wavelength of 355 nm, beam size of 1 mm², fluence of 0.55 J/cm², number of pulse/position of 30 and frequency of 10 Hz), (**a**) Before cleaning, (**b**) After cleaning.

As already shown in Figure 3, the cleaned surface was free of any hydrocarbonbased contaminants, indicating an exhibit of higher reflectivity compared to the uncleaned surface. Additionally, having shown in Figure 3 the similar surface morphologies from both the laser cleaned and uncleaned surfaces, with surface roughness (R_a) vales being approximately 450 nm, any change in the reflected signal before and after laser cleaning will be predominately associated with the cleaning process. This ensured the monitoring of the variation in intensity of the reflected beam from the surface as recorded by PBR and its corresponding signal for each pulse within the laser cleaning process using an oscilloscope for various laser fluence levels and number of pulses. The results for the change in reflectivity intensity with an increase in the number of pulses for various laser fluences are presented in Figure 5, where in each case a sharp increase in the reflected intensity was observed for the first few numbers of pulses. This observation is considered as an effect related to the removal of contaminants from the surface of the titanium alloy [14]. Further shown in Figure 5 is that for all laser fluence levels, after an initial increment in intensity, the reflected intensity remained constant with an increase in number of pulses for the next 70 to 100 pulses before it started to decrease again. This subsequent decrease in reflected intensity could be attributed to oxide formation at a higher number of laser pulses. A deduction that could therefore be made from this is that there was no oxide formation within the first 50 pulses, but rather the increase in the reflected PBR signal strength noted during those pulses could predominantly be due to the effective removal of the hydrocarbon-based contaminants that are typically found in uncleaned surfaces, as shown in Figure 4.

Observed in Figure 8a,b is that no specific wavelength peaks are associated with the hydrocarbon-based contaminants. This observation could be attributed to the magnitude of the contaminants observed over the substrate prior to the laser cleaning process, as presented in Figure 3, and found to be in line with observations in previous work [16–18] in which laser-induced breakdown spectroscopy was used for laser cleaning application with a significant volume of contaminants. Therefore, in the case of laser cleaning with minimal contaminant removal only and no substrate damage, the PES signal is not strong enough to differentiate the materials removed. This implies, the PES signal can be used as an initial technique to estimate the wavelength of the highest emission related to the substrate ablation (in this case 498 to 502 nm), which can then be used as a reference wavelength for monitoring the laser cleaning process along with other techniques like narrow-band photodiode-based monitoring.

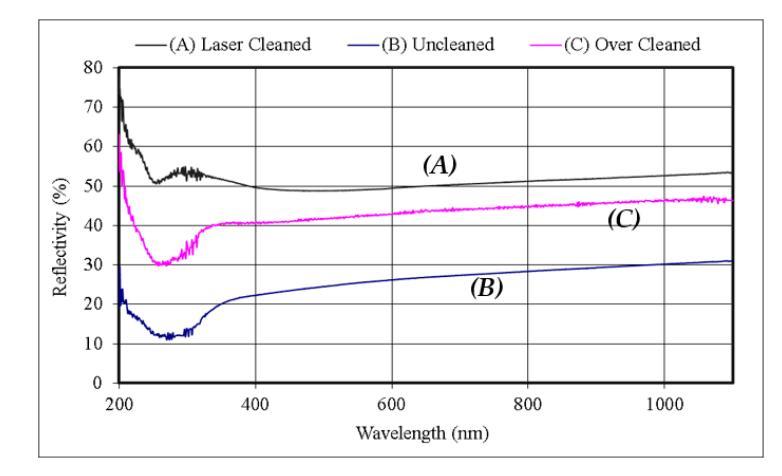
Figure 4. Reflectivity spectrum of a typical workpiece used for laser cleaning.

At a wavelength of 635 nm, which corresponds to the wavelength of the diode laser to be used for monitoring, the figure shows the reflectivity of the laser-cleaned, uncleaned, and overcleaned samples to be 49%, 28%, and 44%, respectively. The least value of reflected intensity observed for the overcleaned sample is possibly due to surface oxidation [12] of titanium alloy samples processed with a large number of pulses. Since there was a discerning difference in reflectivity of cleaned, uncleaned, and overcleaned samples, the monitoring process was expected to be feasible using a 635 nm diode laser for the PBR method.

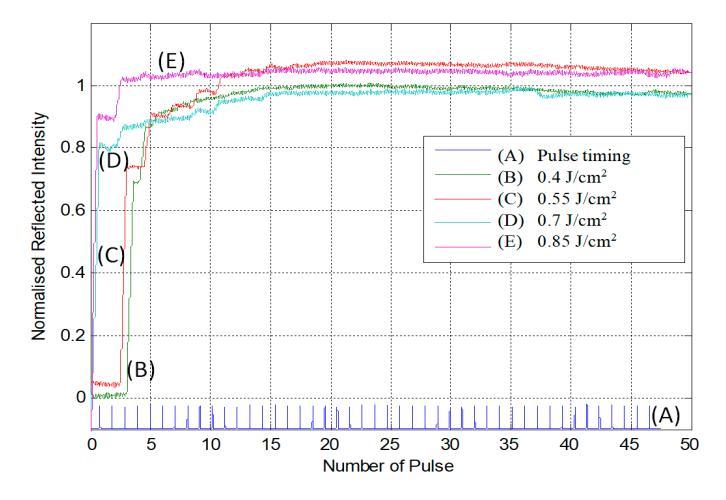
Further experimentation on PBR was carried out using a moving beam as an exploration to the implementation of the monitoring system in laser cleaning of large areas. The diode laser beam and the frequency-tripled Nd:YAG laser beam were set stationary while the workpiece was moving. To establish the effect of laser cleaning performance on the PBR intensity, recording of the intensity was carried out at three instances along the same linear laser cleaning track, i.e., before cleaning, during cleaning, and after cleaning. A comparison of the reflected intensities at the three respective instances stands to provide an indication of the effectiveness of the PBR system as an online monitoring technique in the frequency-tripled Nd:YAG laser cleaning process.

Figure 5. Effect of laser fluence on change in reflectivity of PBR with an increase in number of pulses for a stationary laser beam (beam size = 1 mm^2 , frequency = 10 Hz, monitoring laser wavelength = 635 nm).

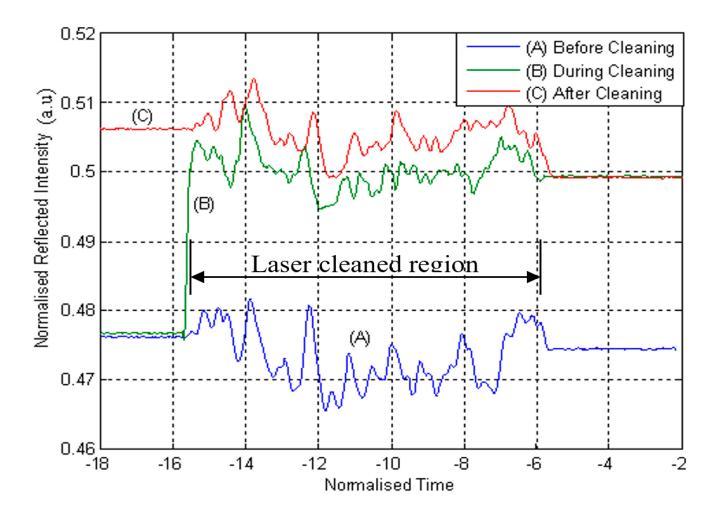
Details of the reflected intensity of the PBR system as recorded along the same line before, during, and after laser cleaning for a laser fluence of 0.55 J/cm² and 20 pulses per position are presented in Figure 6, where a distinct difference in reflectivity of the workpiece before and after laser cleaning can be observed. This is an indication of the quality of cleaning of the substrate after the laser cleaning process. The figure also indicates that during laser cleaning the reflectivity increases sharply as the laser beam starts to clean the workpiece surface and maintain its level as the cleaning progresses.

Figure 6. Effects of laser cleaning on PBR intensity along a linear track (beam size = 1 mm^2 , fluence = 0.55 J/cm^2 , No. of pulse/position = 20, frequency = 10 Hz, monitoring laser wavelength = 635 nm).

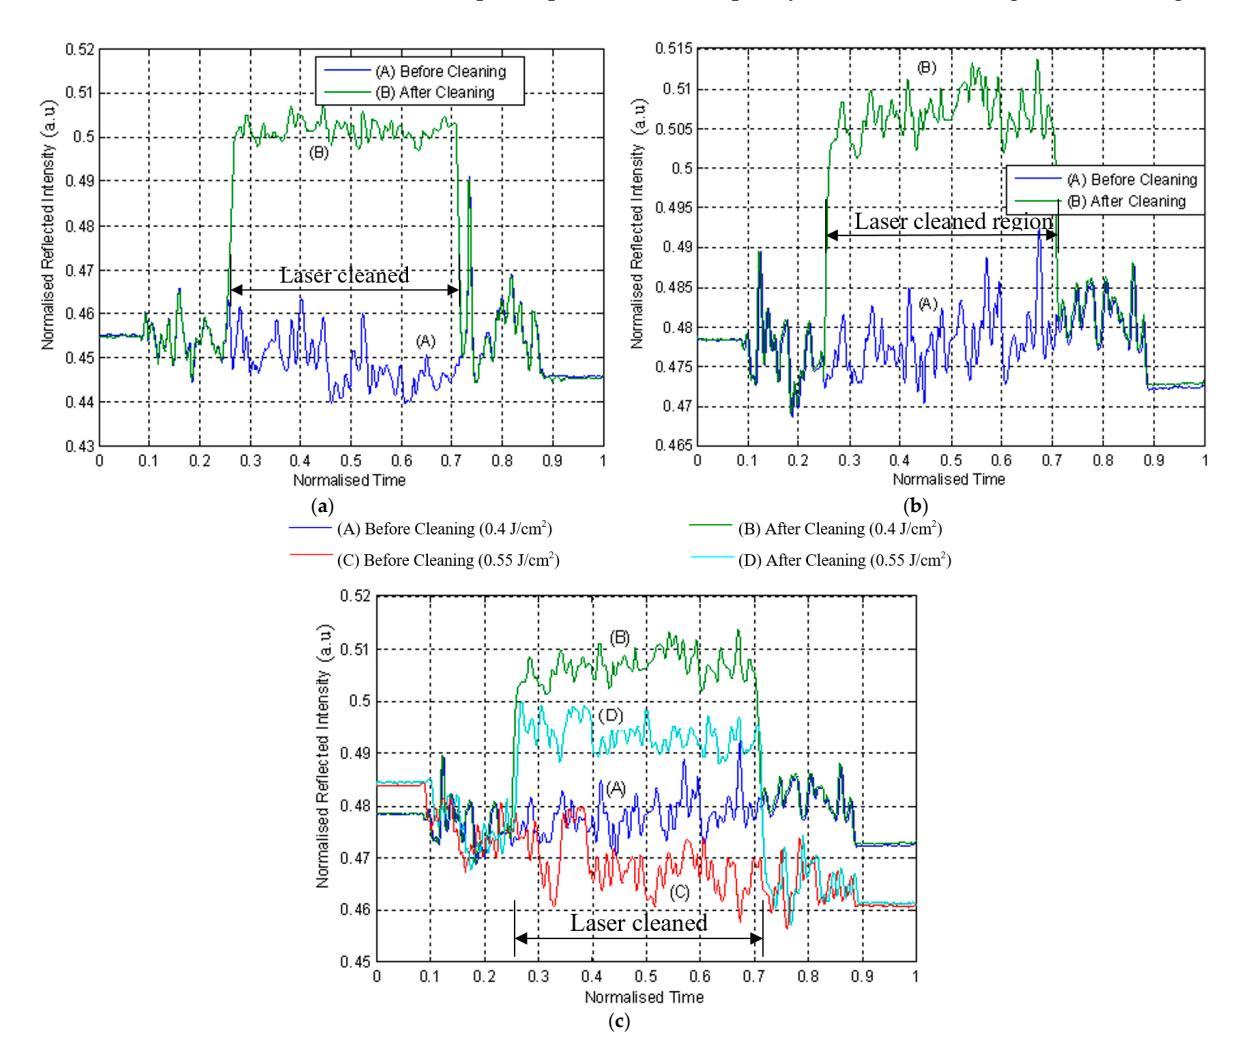
Figure 7a–c depicts the measured reflected intensity of the diode laser in monitoring the laser cleaning of a large area with a moving workpiece. While Figure 7a presents the variation of the measured intensity over an area without any added contaminants before and after laser cleaning for a laser fluence of 0.55 J/cm², Figure 7b presents a similar variation for an area with added contaminants, before and after laser cleaning, for the same value of laser fluence. In Figure 7c, the variation of the measured intensity over an area with added contaminants before and after laser cleaning and for varying laser fluence is shown. In all cases and irrespective of the laser fluence, a distinct difference was observed in the reflected intensity measured before and after laser cleaning, with the laser-cleaned region in all cases showing higher reflected intensity than the uncleaned region. This observation is a portrayal of the effectiveness of the frequency-tripled Nd:YAG laser in cleaning the titanium alloy surface. It is also worthy to note from Figure 7c the increase in laser fluence, which has been observed to cause a marginal increase in the measured intensity of the reflected beam.

Figure 7. Effects of laser cleaning on PBR intensity over an area. (a) Without any added contaminants (beam size = 1 mm^2 , fluence = 0.55 J/cm^2 , No. of pulse per position = 30, frequency = 10 Hz, monitoring laser wavelength = 635 nm), (b) With contaminants (beam size = 1 mm^2 , fluence = 0.55 J/cm^2 , No. of pulse per position = 30, frequency = 10 Hz, monitoring laser wavelength = 635 nm), (c) With contaminants and for various laser fluences (No. of pulse per position = 30, frequency = 10 Hz, monitoring laser wavelength = 635 nm), (c) With contaminants and for various laser fluences (No. of pulse per position = 30, frequency = 10 Hz, monitoring laser wavelength = 635 nm).

The next stage of the experiments on the PBR technique was to establish its effectiveness in monitoring the laser cleaning of a large area. In addition to the as-received contaminated samples, samples with added contamination of industrial machining coolant were also used to evaluate the performance of Nd:YAG laser cleaning and the PBR technique. Here, the reflected intensity of the diode laser was measured twice along the middle of the laser-cleaned area, i.e., once before cleaning and once after cleaning, with the monitoring diode laser beam scanned over the surface at a speed of 1 mm/s.

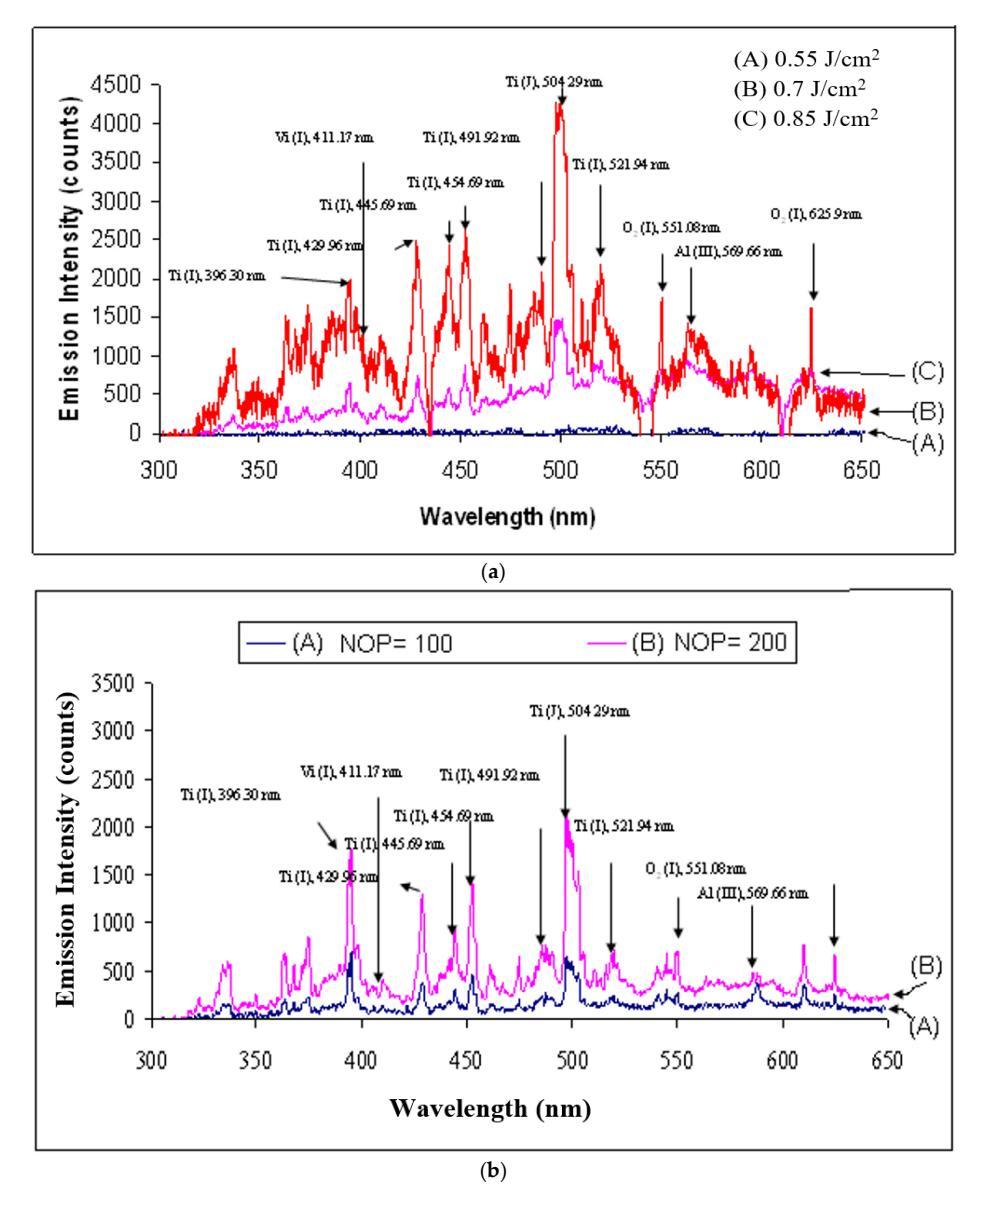
During the laser–material interaction, the contaminates over the substate are ionized, resulting in a plasma plume over the surface. The plasma plume gives rise to light emissions (at various wavelengths), which can extend up to a few millimeters from the surface of the workpiece. The multiwavelength light that is emitted from the plasma plume contains information related to the atomic species that has been ionized, and the spectra thus produced during the laser cleaning process [15,16] can be used to identify the material (corresponding to the wavelengths) removed by the laser. Shown in Figure 8a is a classical PES induced by laser irradiation of titanium alloys for a stationary laser beam operated without any added contaminants, while Figure 8b presents similar details but for a linearly moving laser beam. In both figures, the presence of titanium and oxygen emission lines is found, as discussed in the literature [17]. and with a few peaks of aluminum and vanadium also observed.

Figure 8. Emission spectra of titanium alloys for various laser fluences (**a**) Stationary beam (after 200 pulses, beam size = 1 mm^2), (**b**) Moving beam (fluence = 0.85 J/cm^2 , beam size 1 mm^2 , lens focal length = 200 mm).

Further observed from Figure 8a for the stationary laser beam is that a significant proportion of the noticeable peaks with the most intense emissions occurred in a spectral range of 498 to 502 nm and are of a titanium-neutral signature. Emission signature lines of 529.1, 547.7, 548.7, 551.1, and 625.9 nm were also found to have been included for oxygen, but these were concealed by the titanium emissions within the spectrum because of their relatively low intensities. Furthermore, the required number of pulses for these spectra seemed to have increased as the laser fluence decreased; for any fluence less than 0.7 J/cm² the emission during laser irradiation was found to be so weak that no useful information could be derived from the spectrometer. This is mainly due to the lack of vapor plume or plasma generation at low beam intensities below the ablation threshold for the Ti alloy studied.

In addition to the presentation in Figure 8b of the emission spectra for the linearly moving laser beam, it is also worthy to note for this beam the spectrometer failed to provide any valid spectrum for a fluence less than 0.85 J/cm². The emission spectroscopy is able to provide spectra only for high fluence (just above the ablation threshold of the substrate) and high number of pulses per spot, hence its failure to provide valid spectra within the operating range of the laser cleaning process (less than the ablation threshold of the substrate), which could be an indication of substrate damage. However, a potential solution for direct monitoring of contamination level would be the use of photomultiplier tubes to detect the PES signals when operating at a lower fluence level. While PES has been used by previous researchers [16–18] for monitoring laser cleaning and coating removal processes, the technique is found in this study to have failed to give any valid spectrum within the laser cleaning operating range of titanium alloys. It must therefore be noted at this point that significant emission spectra, as shown in Figure 8a,b can be observed only when a substantial material (either substrate or contaminants) is ablated and ionized to produce light emission.
